Manhole Inspection Summary

Manhole # S29AA_023MH

Insp Date: **4/22/09 1:20 PM**

Location Address: **621 HOFFMAN ST**

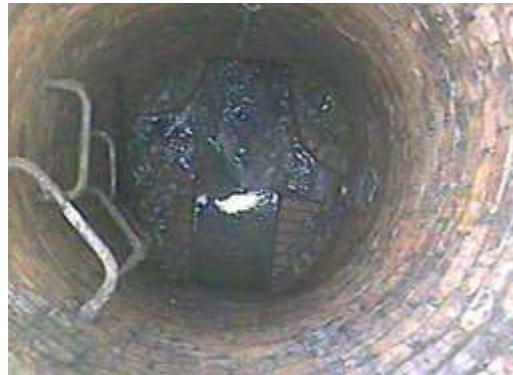
Condition: ☐ Sound ☐ Cracked ☐ Root Intrusion ☐ Deteriorated ☐ Leaks ☒ **Debris**

CHANNEL DEBRIS

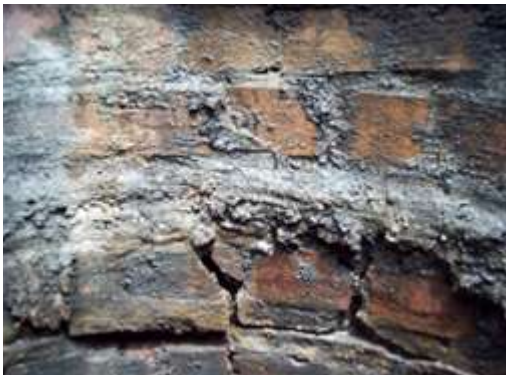
Defect 2

Condition: ☐ Sound ☒ **Cracked** ☐ Root Intrusion ☐ Loose Brick ☐ Deteriorated

CHIMNEY CRACKED

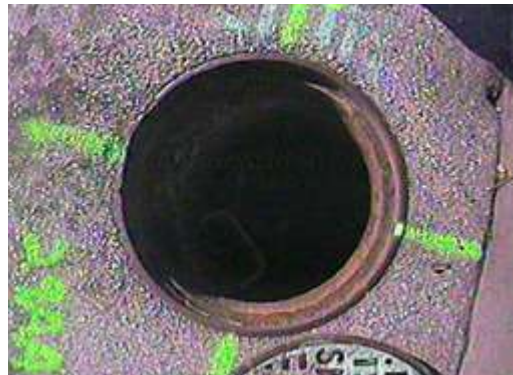
Defect 1

Offset: **4** (in.)

FRAME OFFSET

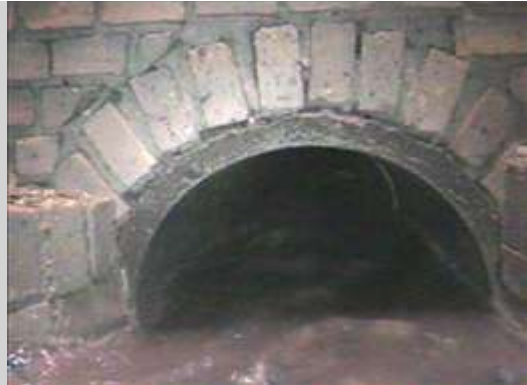
12 O'Clock Outflow

Pipe Height: (in.) Direct
Pipe Material: **Concrete** ☐ Pipe Lined
Invert Depth: **13.03** (ft.) Flow Characteristics: **Slow**
Deposits: ☐ None ☒ **Mud** ☐ Sludge ☒ **Debris** ☐ Grease
Silt Depth: **6** (in.) Deposits Extent: **Medium**
Infiltration: **None** Pipe Seal Cond: **Sound**

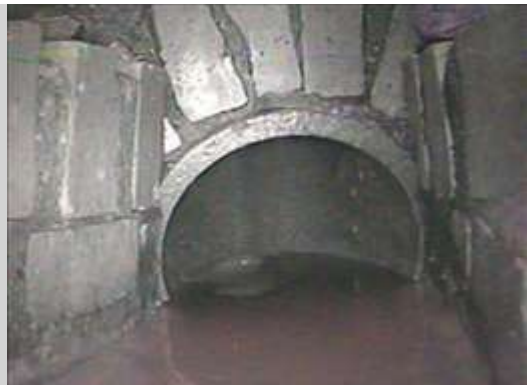
3 O'Clock Inflow

Pipe Height: (in.) Direct
Pipe Material: **Clay** ☐ Pipe Lined
Invert Depth: **12.89** (ft.) Flow Characteristics: **Slow**
Deposits: ☒ **None** ☐ Mud ☐ Sludge ☐ Debris ☐ Grease
Silt Depth: (in.) Deposits Extent:
Infiltration: **None** Pipe Seal Cond: **Sound**

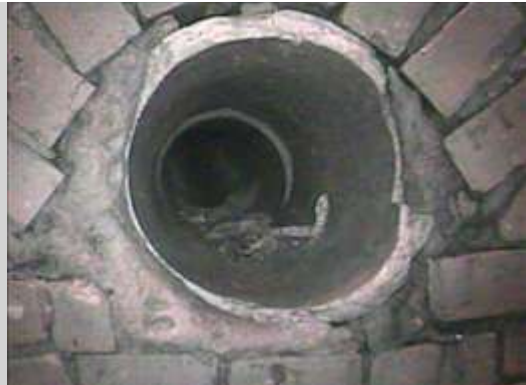
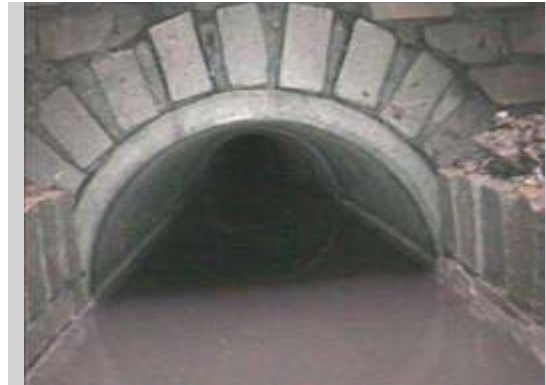
6 O'Clock Inflow

Drop: **Outside Direct**

Drop Condition: **Open**

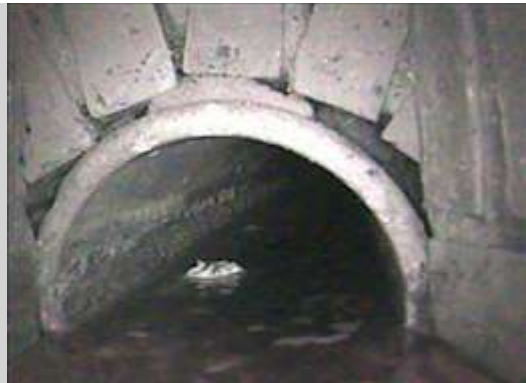
9 O'Clock Inflow

Deposits: ☐ None ☐ Mud ☐ Sludge ☒ **Debris** ☐ Grease

Silt Depth: **2** (in.) Deposits Extent: **Light**
